# Summary of Scanning for Subsurface Voids

# Prepared For: Silver Valley Association

Prepared By: Vanja Dezelic Project Manager – Northeast Ohio 3/4/2020

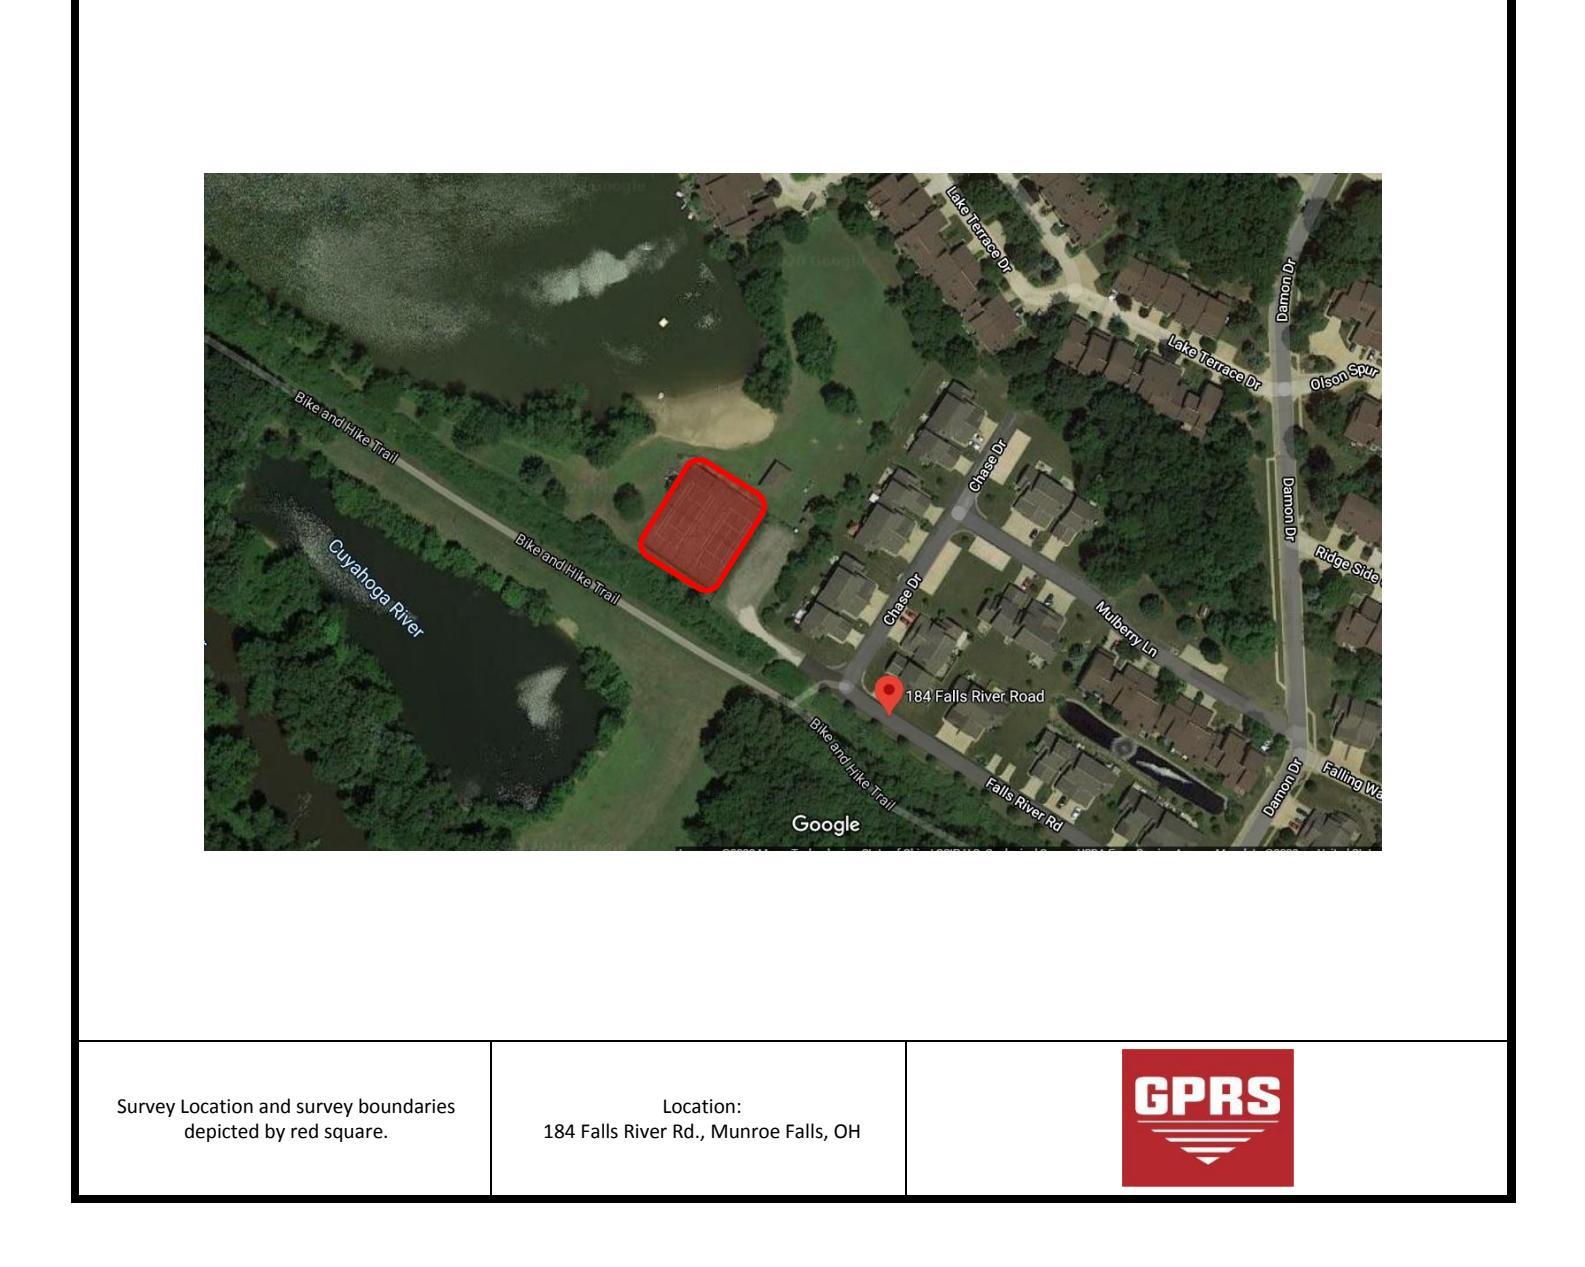
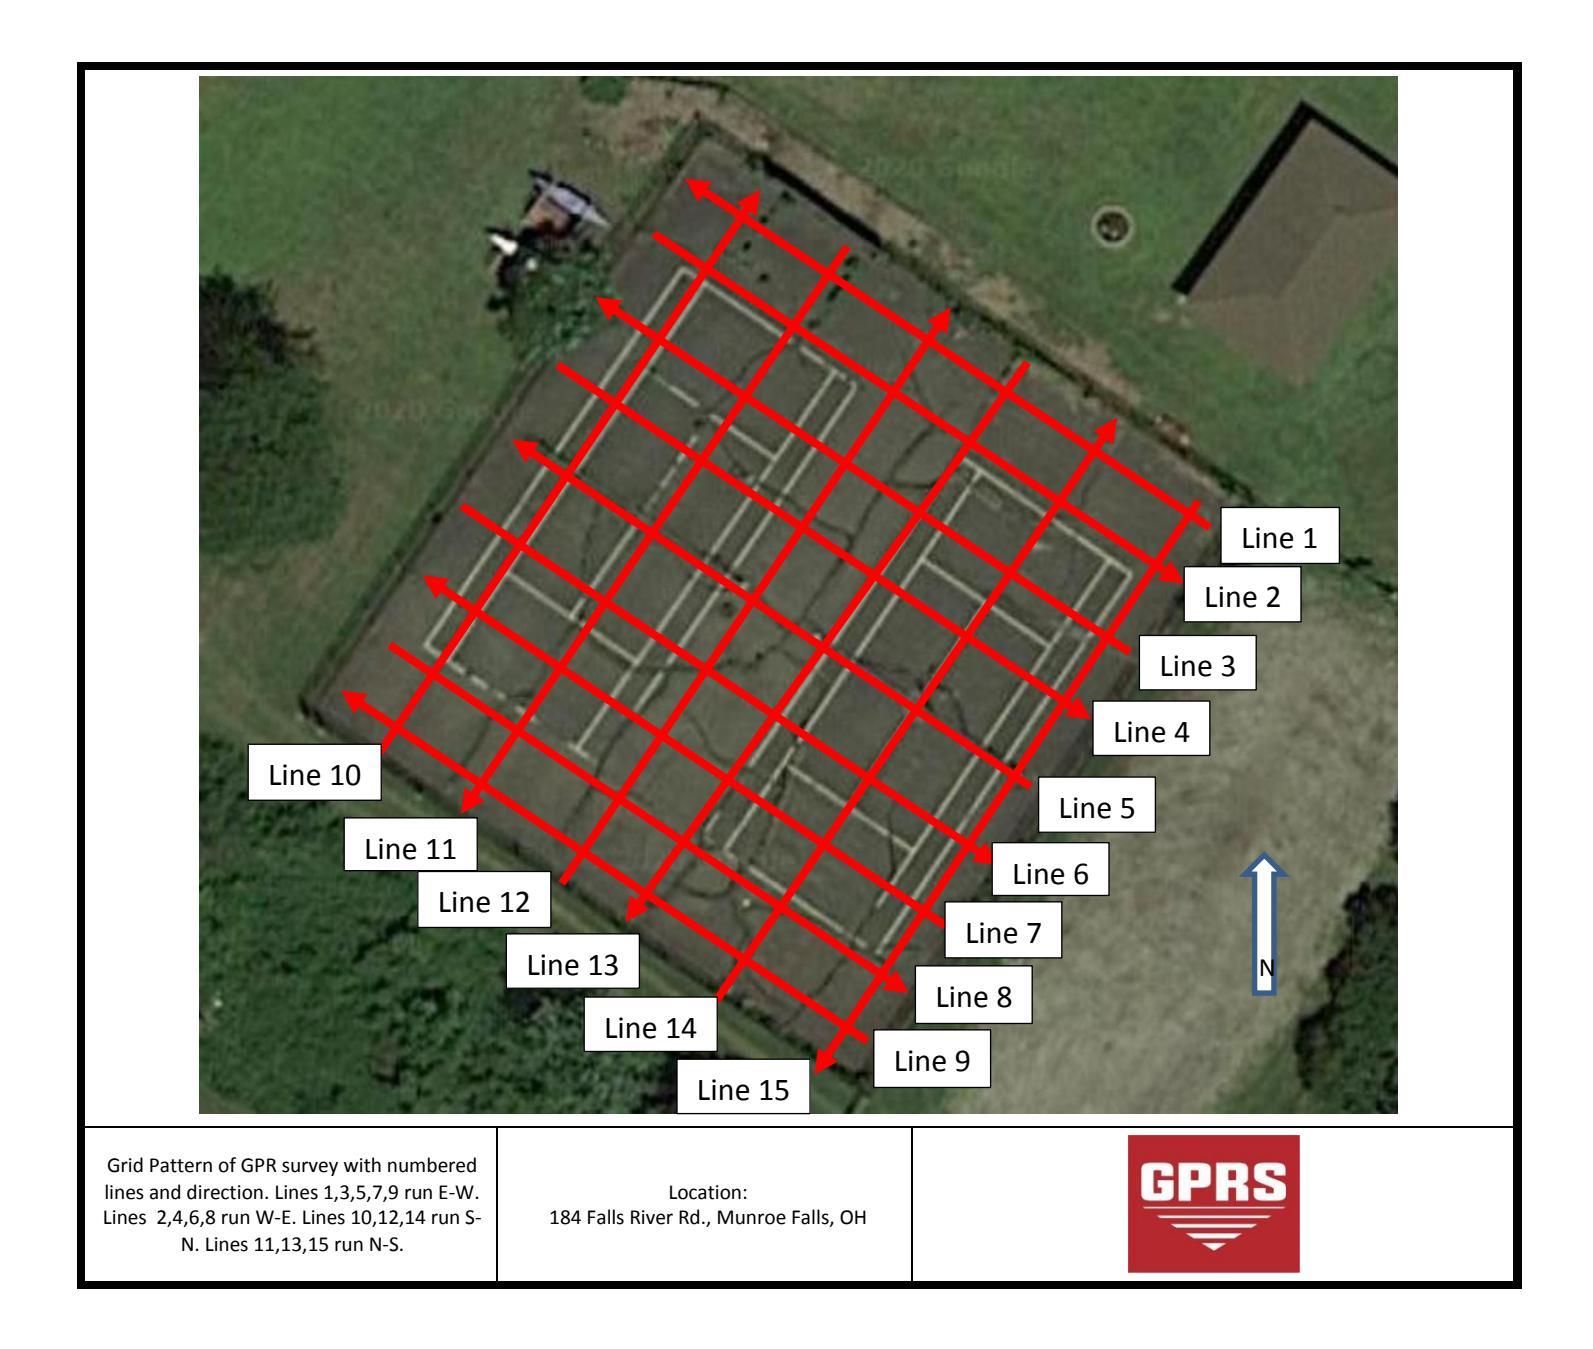
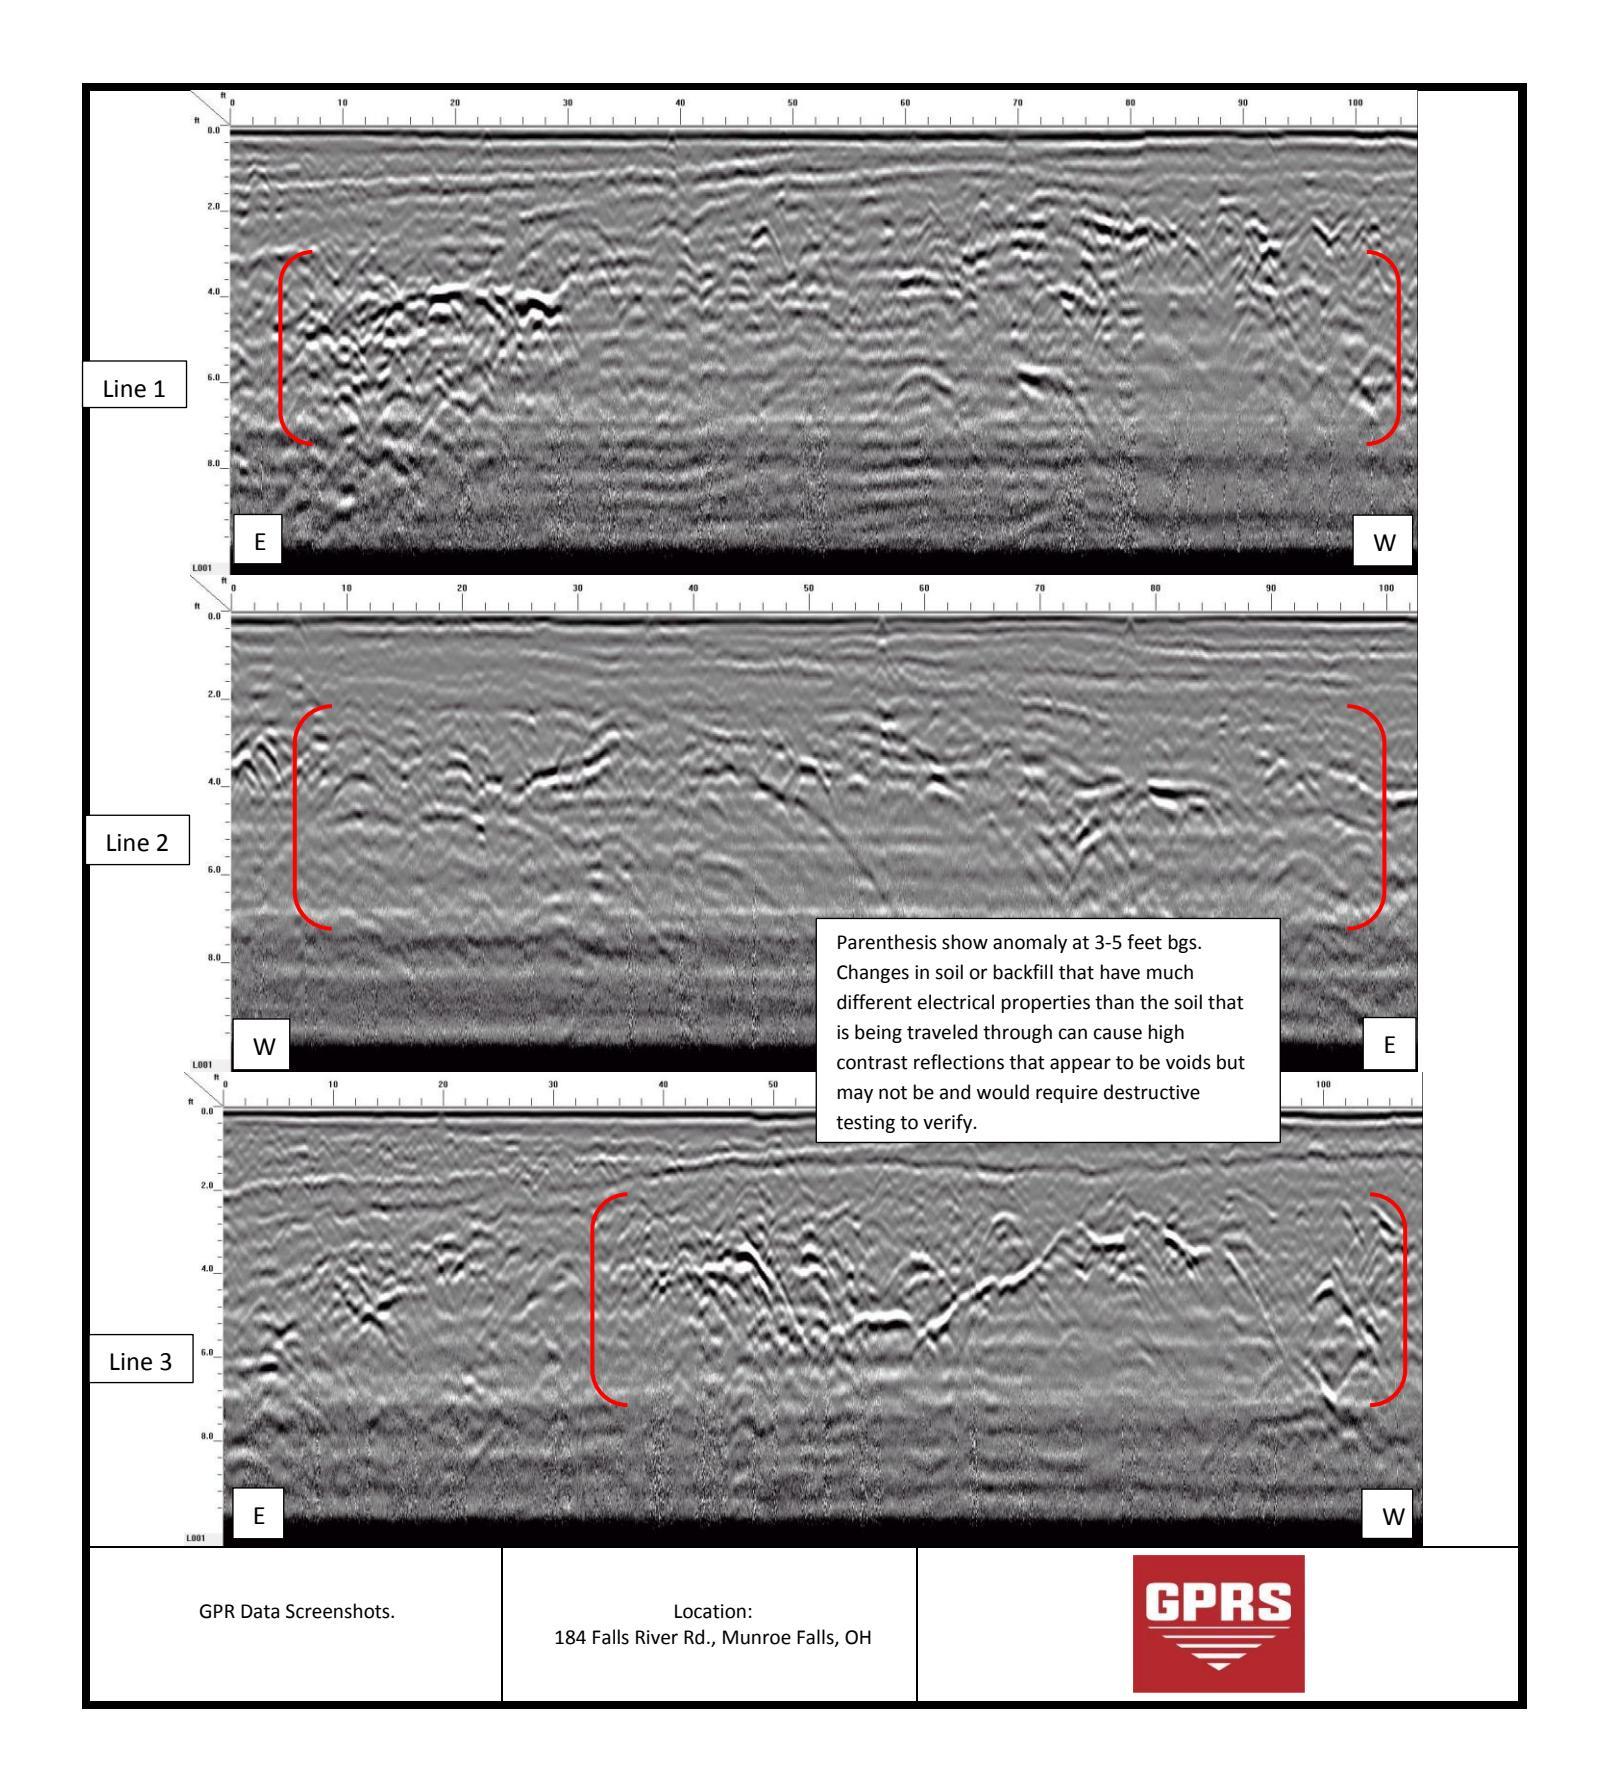
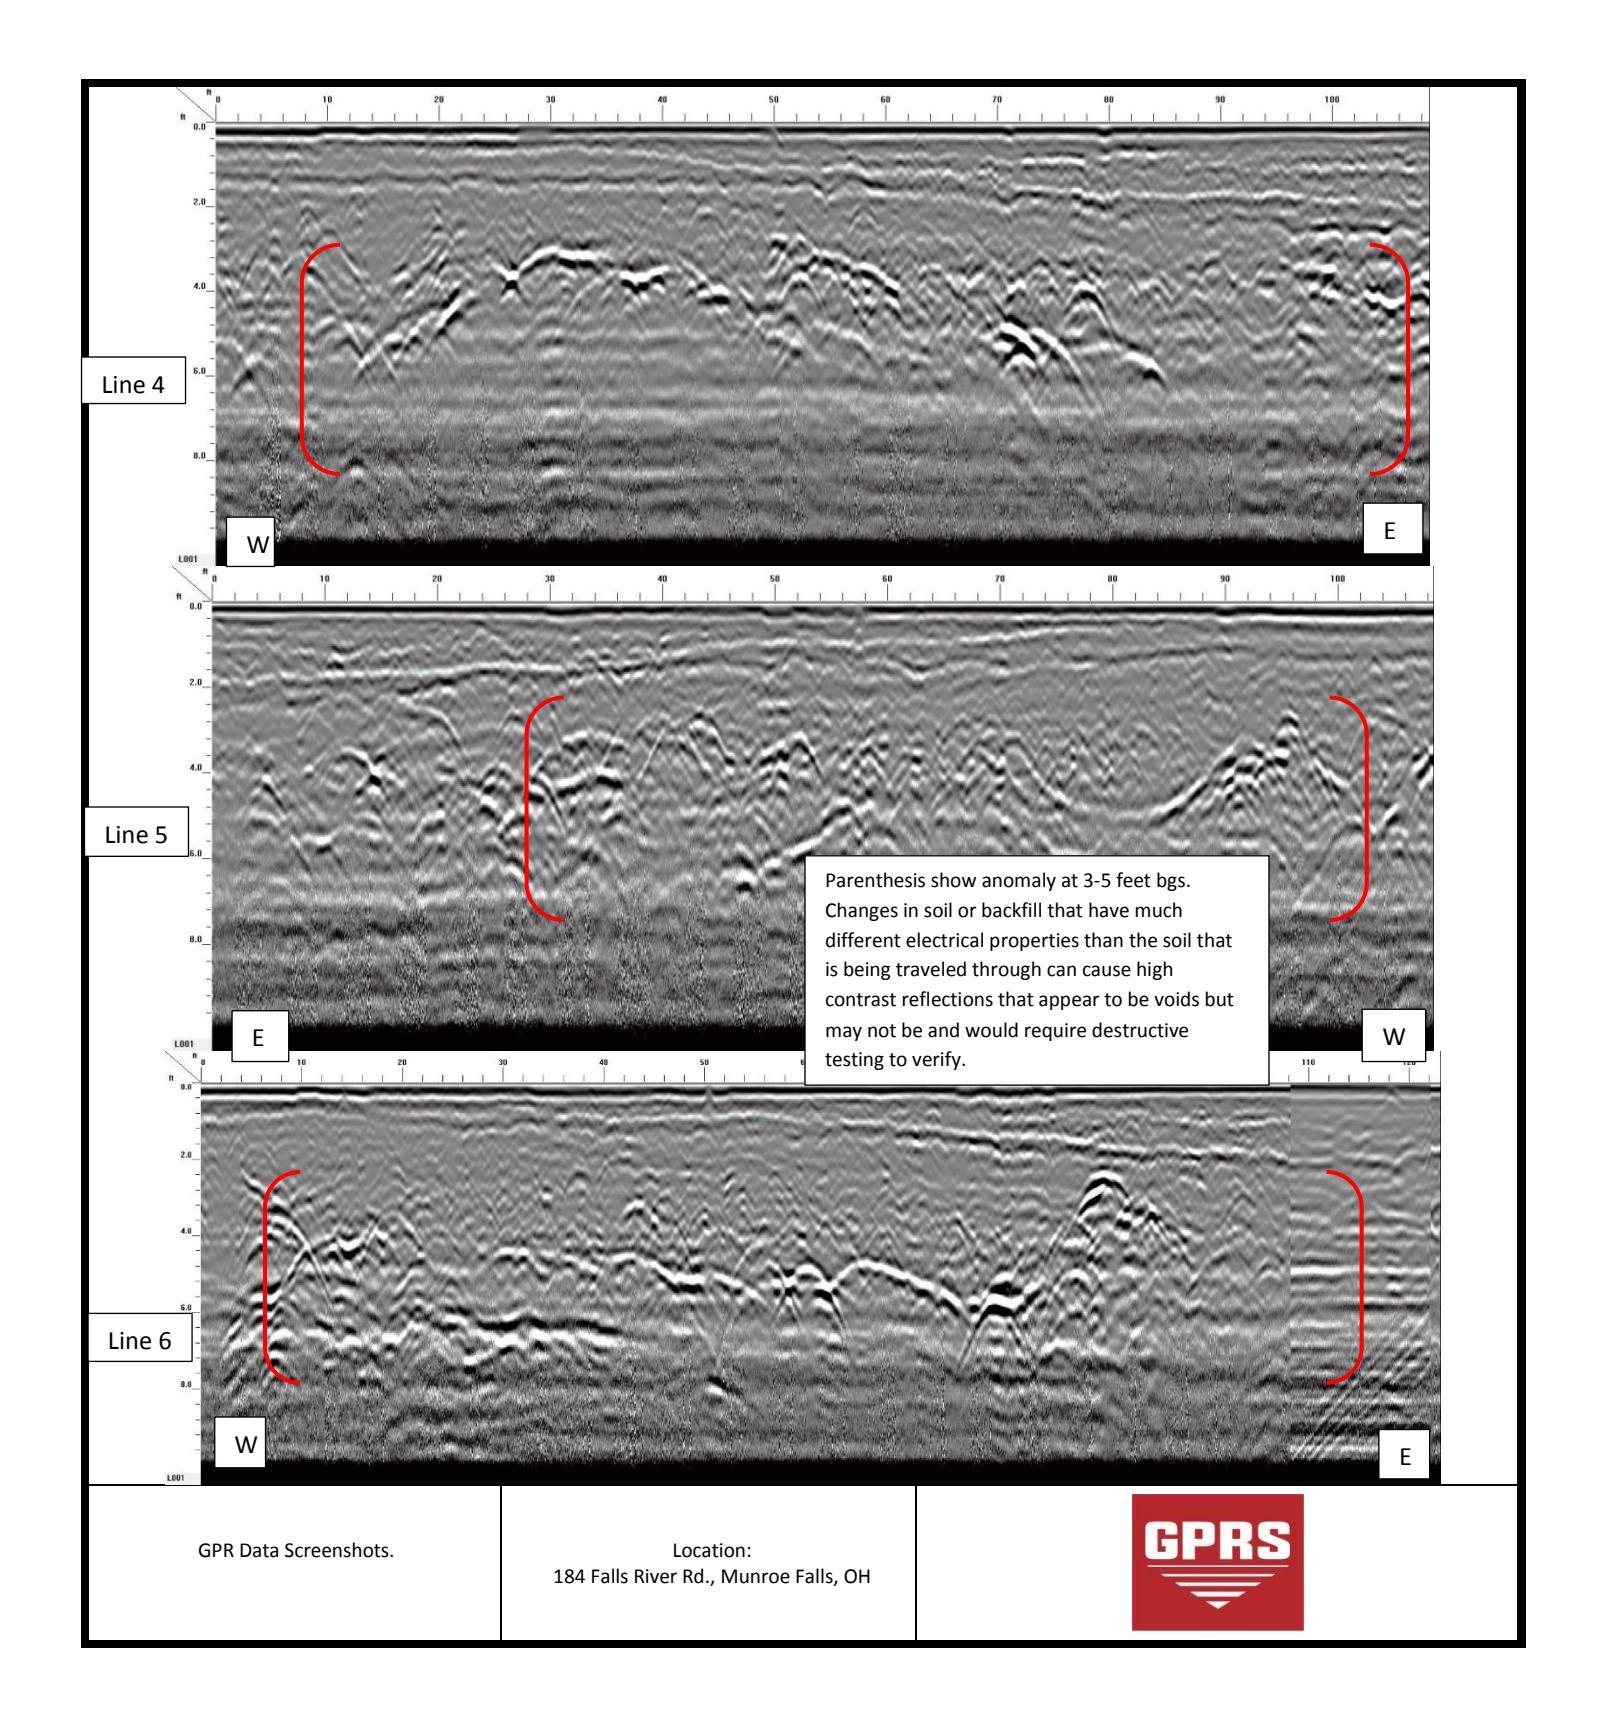
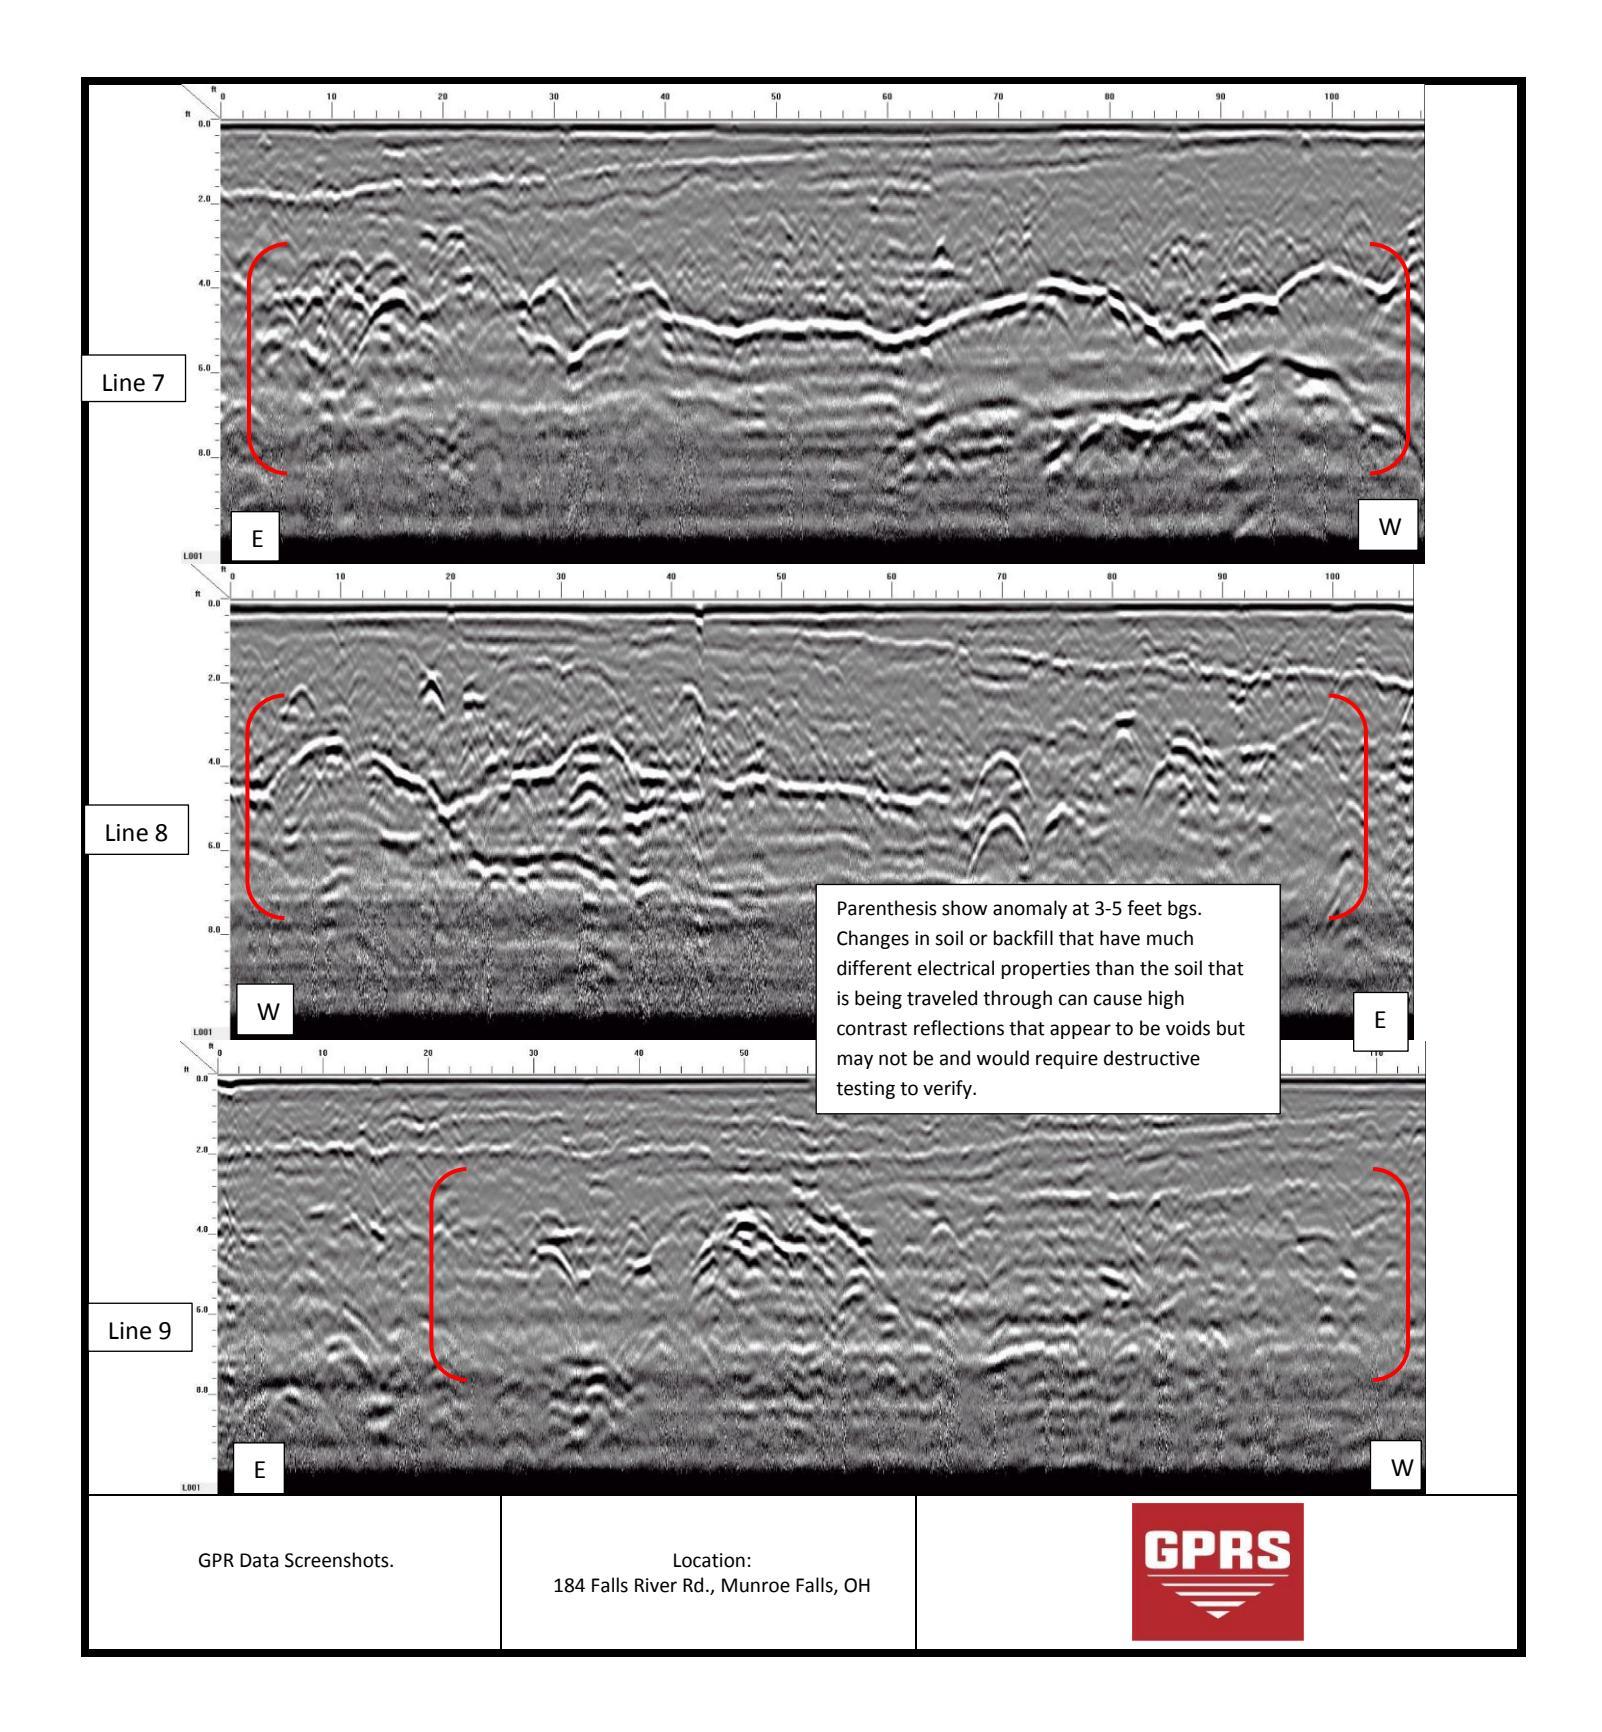
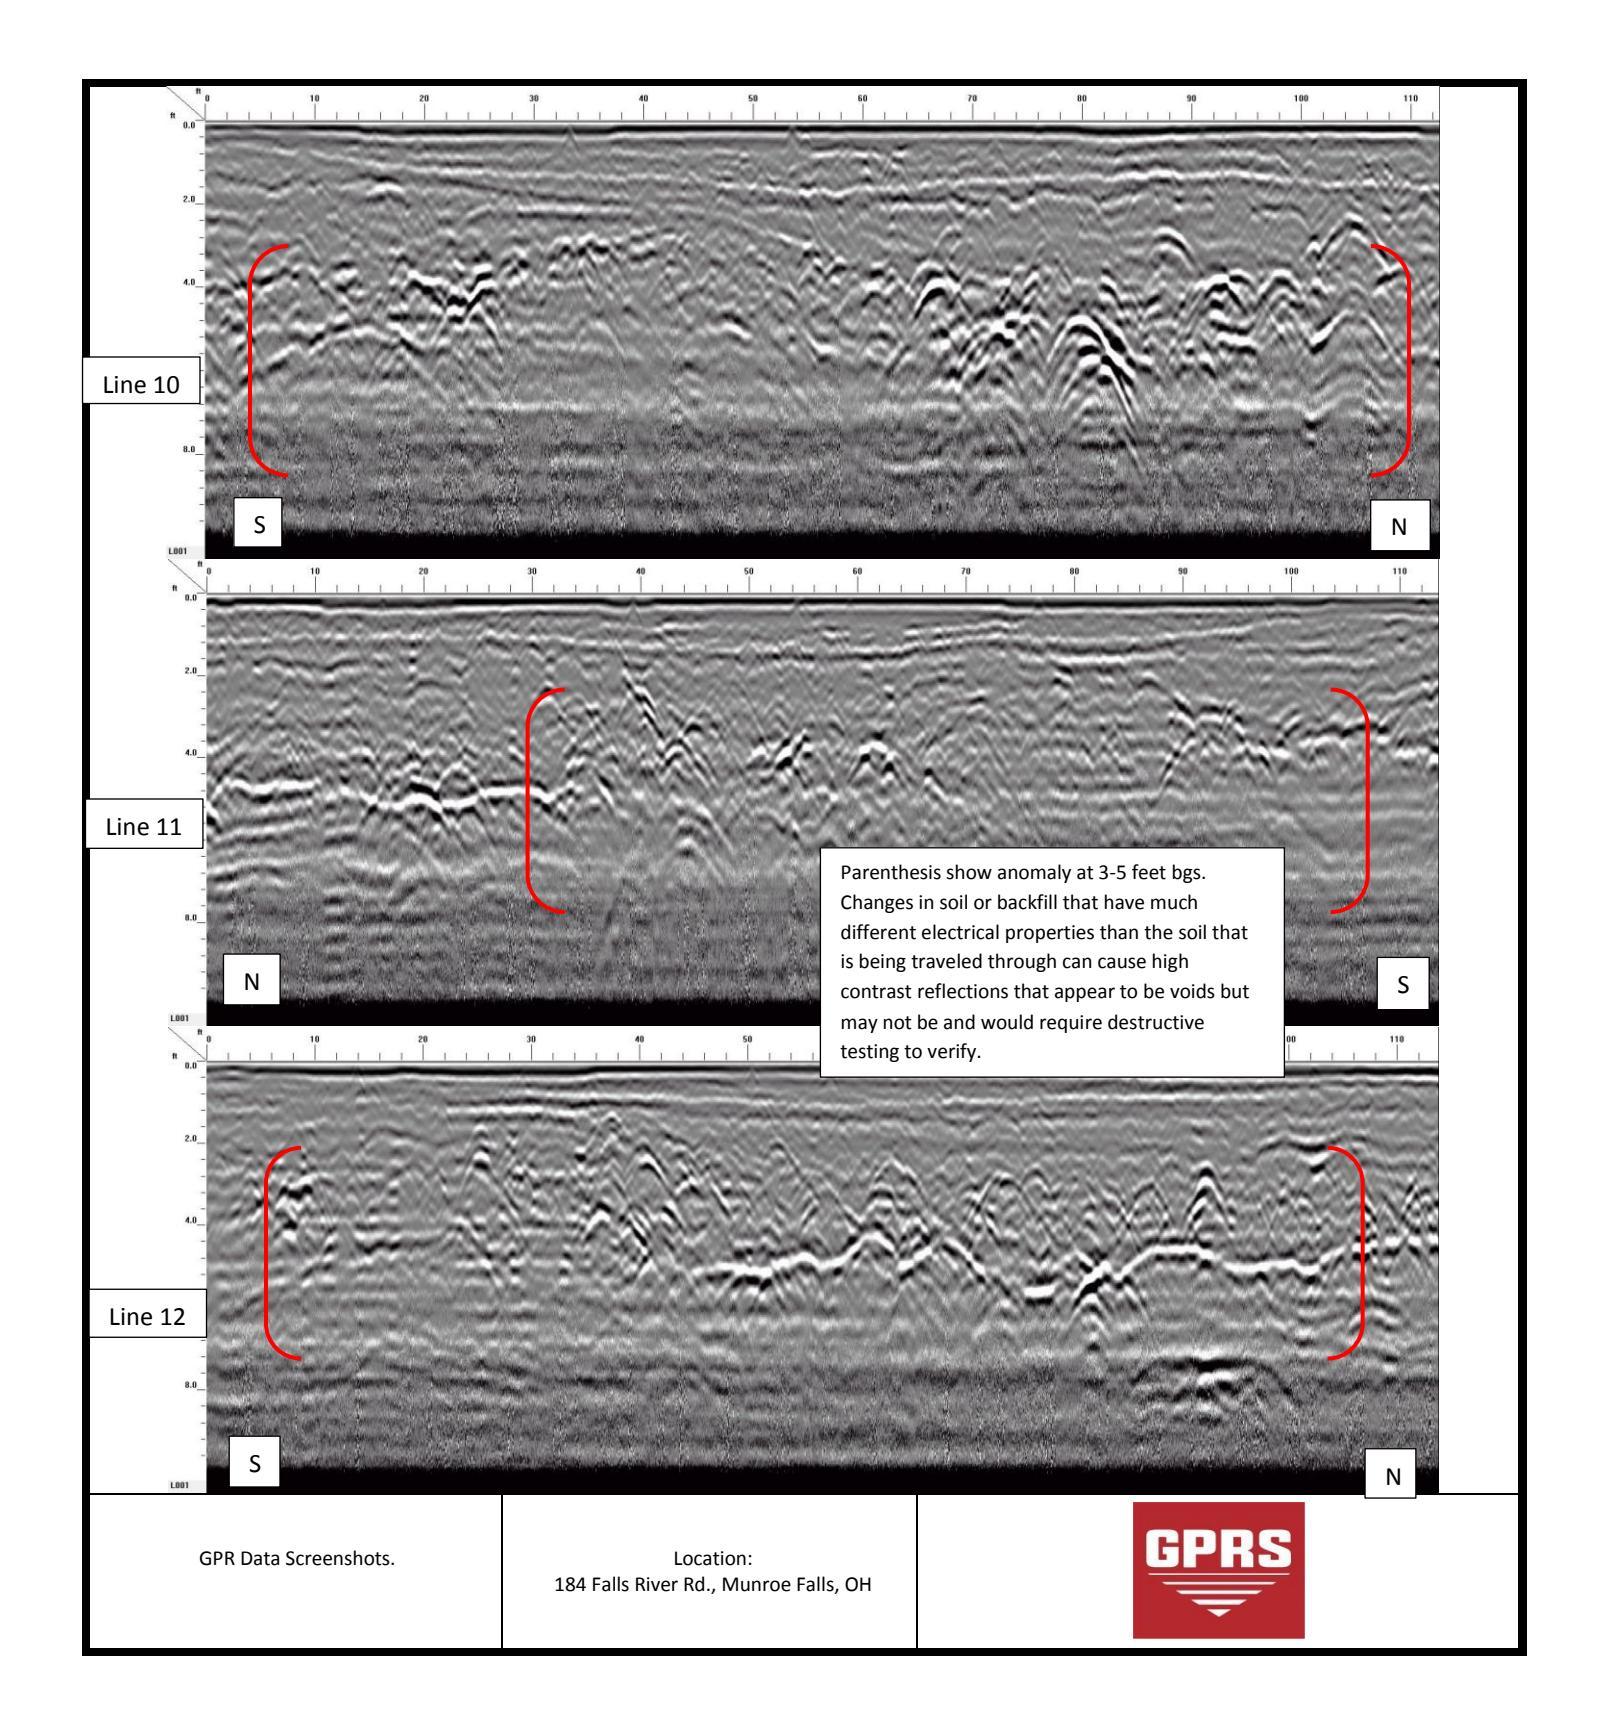
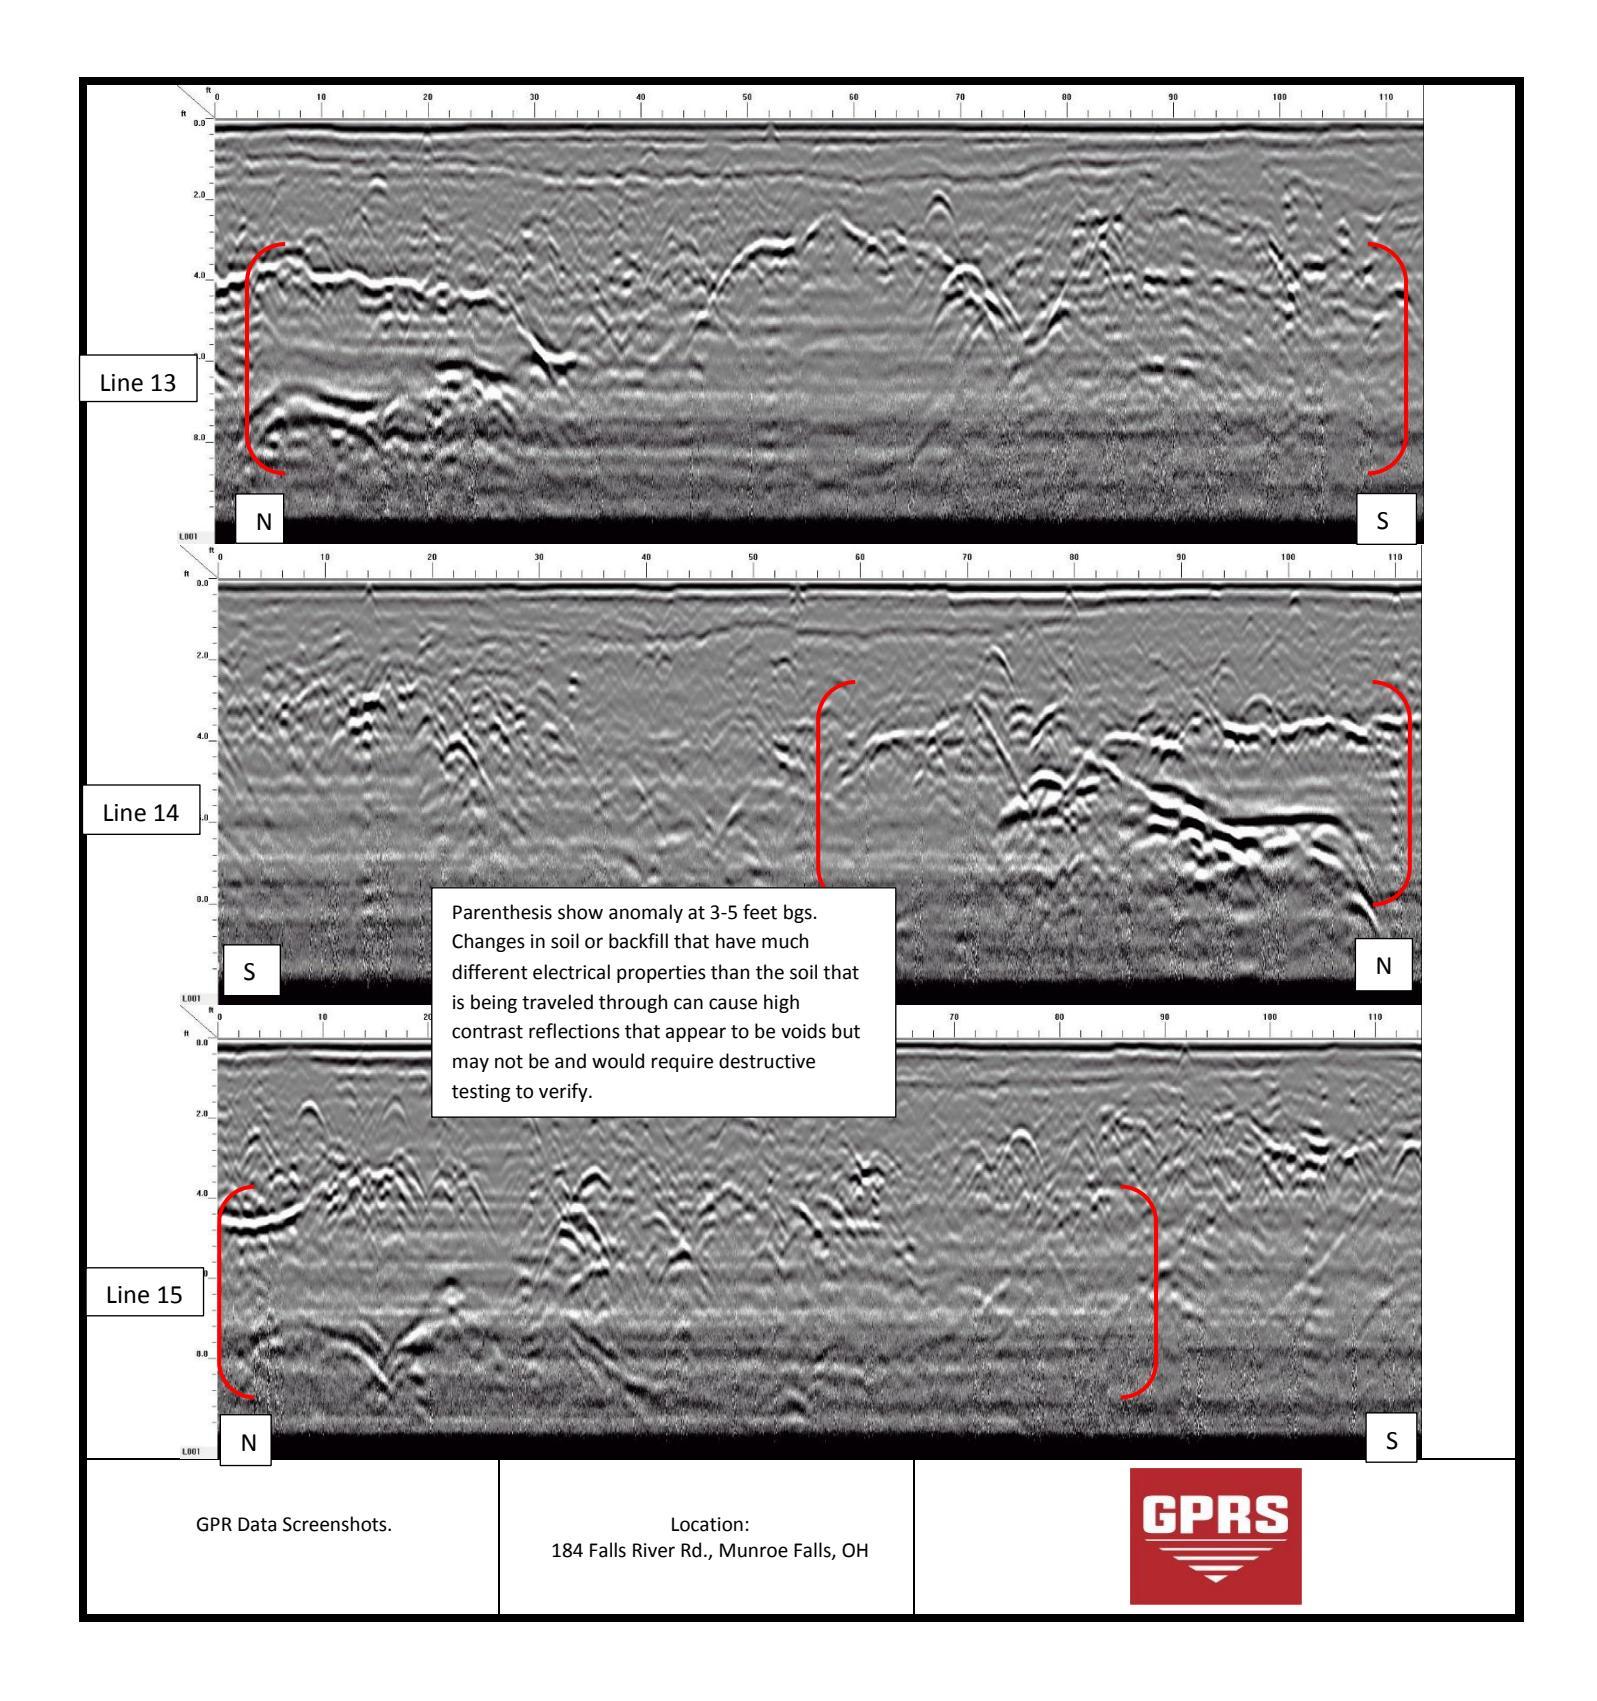
Based on the areas scanned, anomalies were found within the areas shown in the supporting photos, data, and site map provided. The following pages outline data from scans performed during this investigation. No potential utilities were located during the scan process. However, even if they were, they would outside the scope of this particular project. The following pages will provide further explanation of the findings. The GPR data shows a strong boundary at about 1 - 1.5 feet below ground surface (bgs), between the gravel and sand that is located below the asphalt/concrete courts. At about 3 - 5 feet bgs there is an anomalous signature running under the northern area especially. This may be the boundary between the top soil and the quarry landfill boundary, which can be quarry production debris which were deposited in the landfill and then covered with topsoil. This can also be possible voids and also debris such as rocks, But also we must keep in mind that changes in soil or backfill that have much different electrical properties than the soil that is being traveled through can cause high contrast reflections that appear to be voids but may not be and would require destructive testing to verify.
